# Analysis of Abnormal Hotspot Repair on the 500kV South Bandung – Mandirancan Transmission Line T.168 Using the Ohmstick Plus Live-Line Maintenance Method

**Figure 1.** Figure label. T.168 SUTET 500KV BDSLN-MDCAN

Figure 1 shows Tower 168 of the 500kV SUTET BDSLN-MDCAN. The specifications of Tower 168 are as follows:

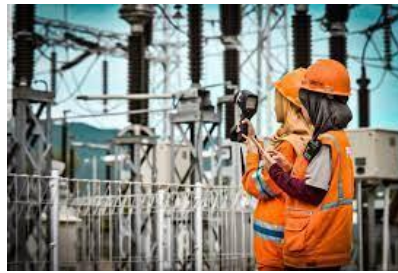
**Figure 2.** Illustration of Thermovision Inspection

To detect hotspot anomalies, regular maintenance is required, specifically Level 1 inspections, which involve thermovision measurements on the BDSLN-MDCAN network from Tower 1 to Tower 186. These measurements are conducted once every six months, or once per semester. For thermovision measurements on the 500 kV SUTET BDSLN-MDCAN towers, a thermovision device from the Flir System brand is used. The thermovision measurement for the tower was carried out on **July 26, 2023**. The results of the inspection revealed that Tower 168 of the 500 kV SUTET BDSLN-MDCAN, particularly on Phase R, exhibited a hotspot anomaly on the conductor jumper clamp and link adjuster.

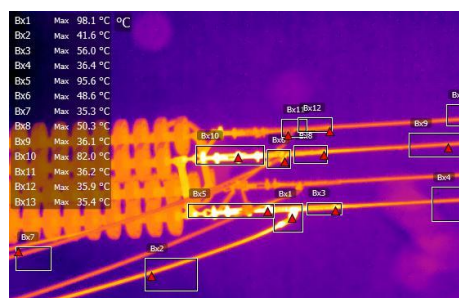
**Figure 3.** Inspection Results of Phase R at Tower 168, Directed Toward Tower 167

During the thermovision inspection, the operator identified anomalies on the conductor jumper clamp and link adjuster of Phase R at Tower 168, directed toward Tower 167, specifically on the lower outer and inner strings. Figure 3 presents the thermovision inspection results for:

Based on the temperature comparison data between connection objects and conductors, two objects on Phase R exhibited hotspot anomalies Outer string terminal jumper clamp: 26°C and Inner lower string terminal jumper clamp 128,4 °C Additionally, the **link adjuster**, which is not designed to carry electrical current, recorded the highest hotspot anomaly with a temperature of 123,3 °C, below is a summary of the data and recommendations for follow-up actions:

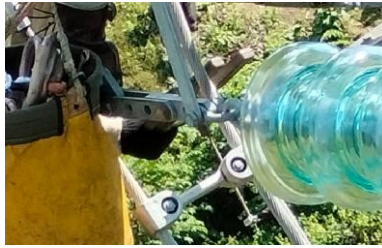
**Figure 4.** Installation of Ohm Stick Plus

Place the Ohm Stick Plus on a conductor carrying at least 2 A of AC current, as shown in Figure 4. It is crucial to establish contact between the conductor and the voltage sensor, specifically the V-shaped plate between the jaws, and the voltage probe. The measurement begins as soon as the Ohm Stick Plus is positioned and stabilized.

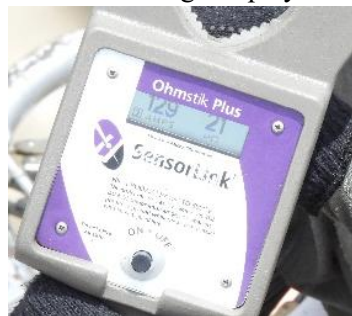
**Figure 5.** Ohm Stick Plus Measurement Results

Be cautious to ensure that the instrument remains stationary during measurement. Keep the Ohm Stick Plus in position for at least five seconds to allow for accurate measurement. While the Ohm Stick Plus is performing the measurement, the word “Sampling” will appear on the display. Once the measurement is complete, remove the Ohm Stick Plus from the conductor and review the readings displayed on the screen.

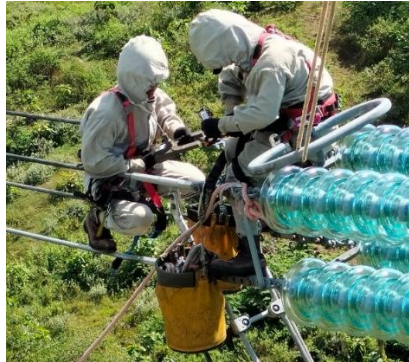
**Figure 10.** Measurement Before Repair

In the thermovision and OhmStik Plus results, the  $\Delta T$  value for the inner lower clamp was  $128.4^{\circ}\text{C}$  with a resistance of  $722\mu\Omega$ , while the outer lower clamp showed a  $\Delta T$  value of  $26^{\circ}\text{C}$  with a resistance of  $1.5\text{m}\Omega$ . Resistance measurements of the jumper clamps were carried out using

the OhmStik Plus without de-energizing the system. The measured current for the outer lower string was 162A162 A162A, and for the inner lower string, it was 183A183 A183A. The following is an illustration of the measurement using the Ohm Stick Plus:

From the measurement results, it was found that the cause of the hotspot was the high accumulation of dust and dirt in the jumper gaps, which caused the temperature to rise. The method for repairing this issue involves opening the jumper clamp and cleaning it using steel wire and sandpaper. Once cleaned, reattach the jumper, then measure the conductor current, jumper current, and clamp resistance, and perform a temperature measurement on the clamp to ensure it is in normal condition.

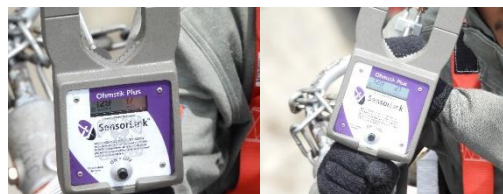
**Figure 12.** Measurement After Repair

The measurement results showed that the resistance of the outer string jumper clamp was 22  $\mu\Omega$  with a current load of 167 A, and the resistance of the inner string jumper clamp was 17  $\mu\Omega$  with a current load of 166 A. The temperature readings can be seen in the following thermovision image.

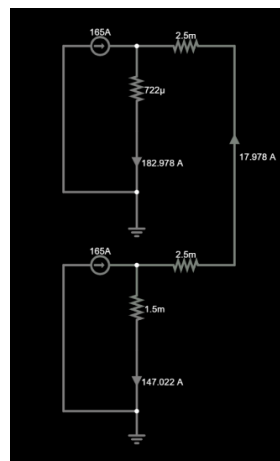
**Figure 14.** Circuit Model of Hotspot Anomaly

In the case of the hotspot at SUTET BDSLN-MDCAN T.168 Phase R, the abnormal hotspot occurred on the link isolator. Under normal conditions, the link does not carry current, so a hotspot anomaly would not appear. In this case, the current passing through the link is due to current distribution between the jumper conductor and the link at the jumper clamp point. This condition is illustrated in the diagram below:

As we know, current flows from high potential to low potential along the path with the least resistance. Branching in a circuit divides current inversely proportional to the resistance values. The diagram above shows that the current passing through the inner lower conductor is divided

towards the outer lower jumper conductor, which passes through the link isolator. This occurs due to a significant contact resistance difference between the outer and inner lower clamps. Consequently, a portion of the current passes through the link isolator, generating heat because the link material is not designed to conduct electricity.

From the data on the causes of the hotspot on the link, the solution is to reduce the resistance of the outer and inner string jumper clamps. This ensures that a small portion of the current from the inner lower clamp is not redirected to the outer lower clamp via the link. Measurements revealed that the hotspot was caused by high levels of dust and dirt in the jumper gap and loose clamp bolt torque, which increased the temperature. The repair steps involved cleaning the outer and inner lower jumper clamps and tightening all jumper clamps with a torque wrench. This was intended to lower the resistance of the outer and inner lower jumper clamps. By balancing the resistance between the outer and inner clamps, no current crosses the string via the link isolator.

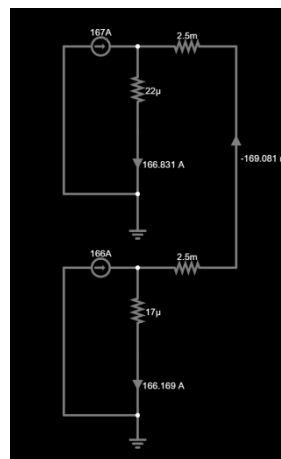
**Figure 15.** Normal Circuit Model

After repairing the conductor jumper clamp by cleaning and tightening the bolts, the resulting current flow was reduced sufficiently, eliminating hotspots on the link in the string set isolator. The normal condition of the lower string circuit is illustrated in the following diagram:

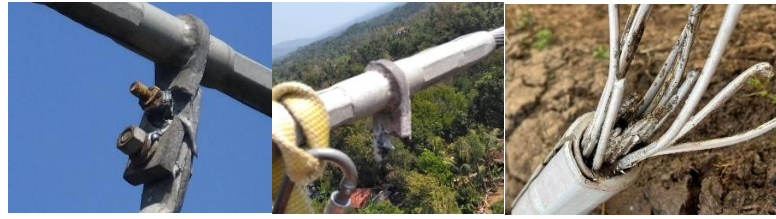
**Figure 16.** Melted Transmission Component

Excessive heat causes the physical condition of components carrying electrical current to melt. This melting results in the components losing their mechanical strength. When components lose mechanical strength, they can cause a disruption in power transmission as the jumper conductor becomes disconnected from the conductor line. The disconnected jumper conductor will sag and may touch the phase cross-arm below it, which is connected to grounding at the tower's base. This will result in a phase-to-ground fault detected by the protection system.
